Natural Conditions Assessment for Low Dissolved Oxygen and pH, Monroe Creek and Tributaries in Westmoreland County, Virginia

**Submitted by
Virginia Department of Environmental Quality**

August 2013

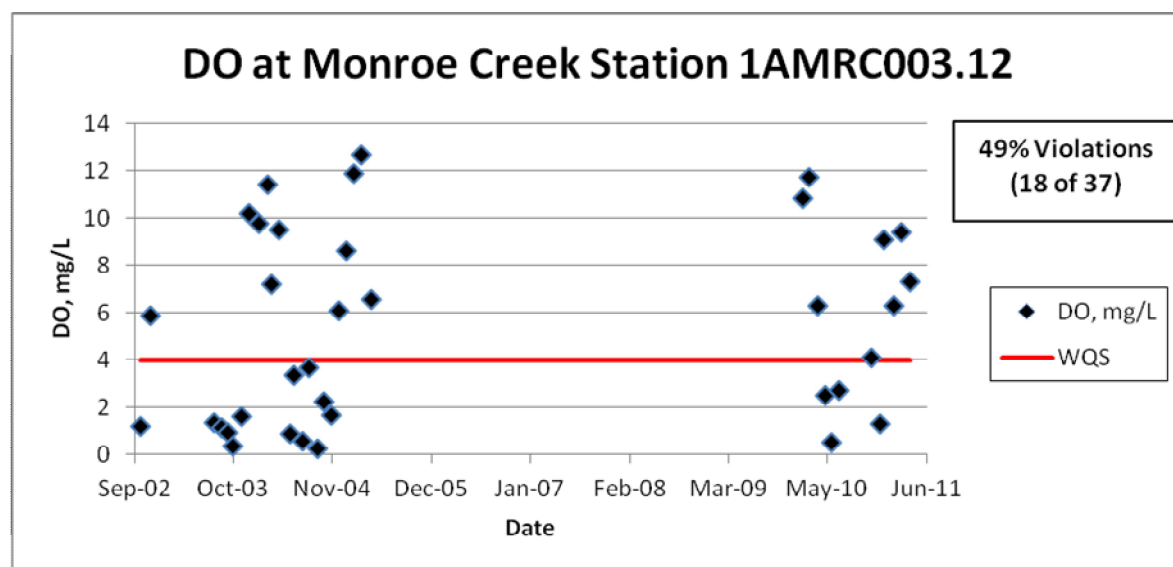
Figure E1. Time series of DO at Monroe Creek station 1AMRC003.12, omitting 4/23/1996 DO = 2.31 mg/l.

DEQ monitored 5 stations on Monroe Creek and tributaries with dates ranging from April 1996 through December 2011. Of the 99 total pH data points recorded, 89 violated water quality standards for pH (90%), and 40 of 99 DO data points violated the water quality standards for DO concentration (40%). The pH minimum and maximum values ranged from 3.3 to 6.8 S.U., and DO values ranged from 0.22 to 12.64 mg/L. All five stations violated the pH and DO water quality standards more than 10.5% of samples. Station 1AMRC002.81 was tidal and the low DO and pH violations in the tidal segment will be nested in the Chesapeake Bay TMDL. Figures E1 and E2 show DO and pH concentrations at the listing station 1AMRC003.12.

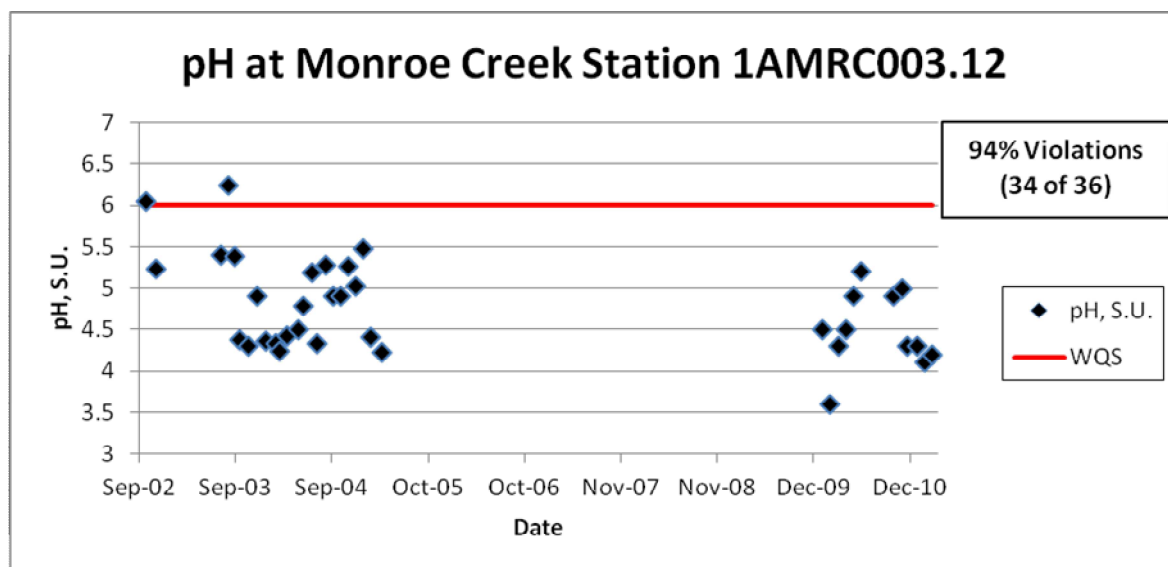
Figure E2. Time series of pH at Monroe Creek station 1AMRC003.12, omitting 4/23/1996 pH = 4.18 S.U.

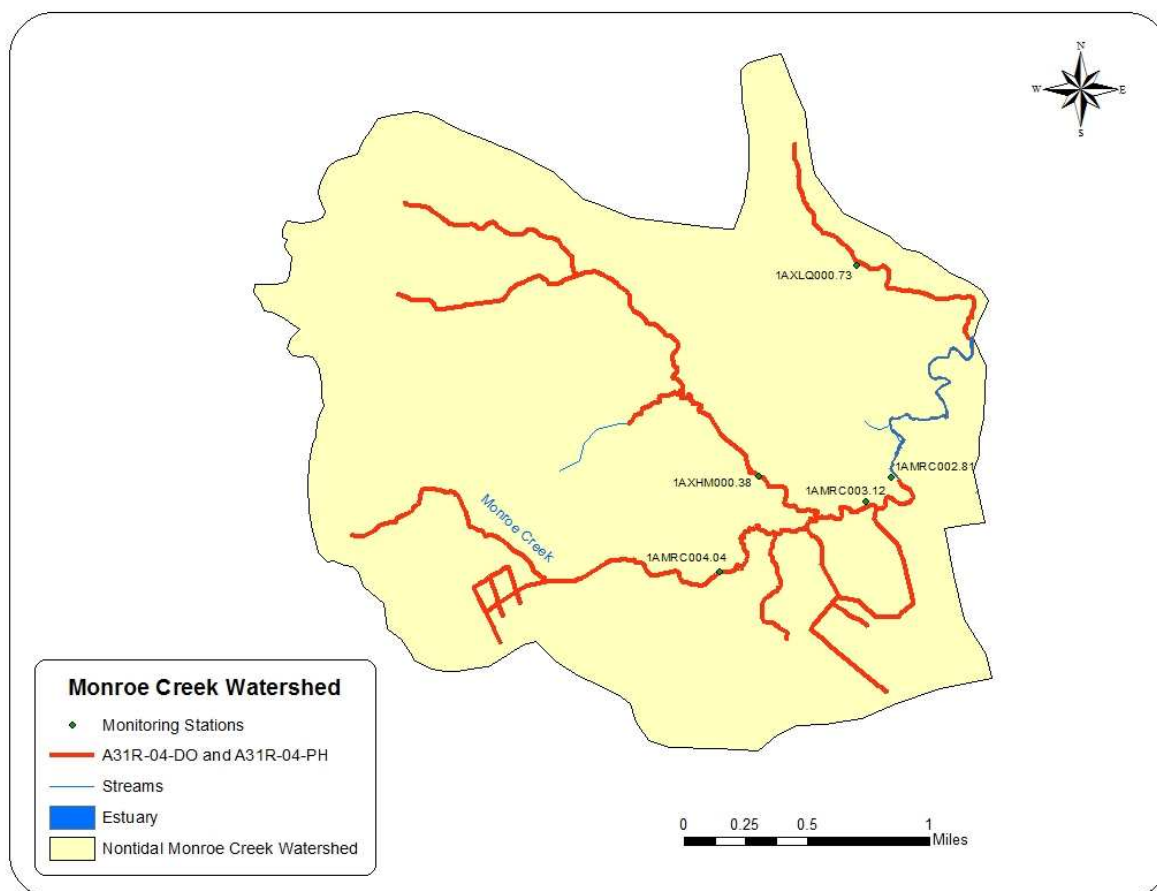
Figure 1. The Monroe Creek watershed map and associated monitoring stations.

DEQ monitored 5 stations on Monroe Creek and tributaries (see Figure 1) with dates ranging from April 1996 through December 2011. Of the 99 total pH data points recorded, 89 violated water quality standards for pH (90%), and 40 of 99 DO data points violated the water quality standards for DO concentration (40%). The pH minimum and maximum values ranged from 3.3 to 6.8 S.U., and DO values ranged from 0.22 to 12.64 mg/L. All five stations violated the pH and DO water quality standards more than 10.5% of samples. Station 1AMRC002.81 was tidal and the low DO and pH violations in the tidal segment will be nested in the Chesapeake Bay TMDL. The results are summarized in Table 3.

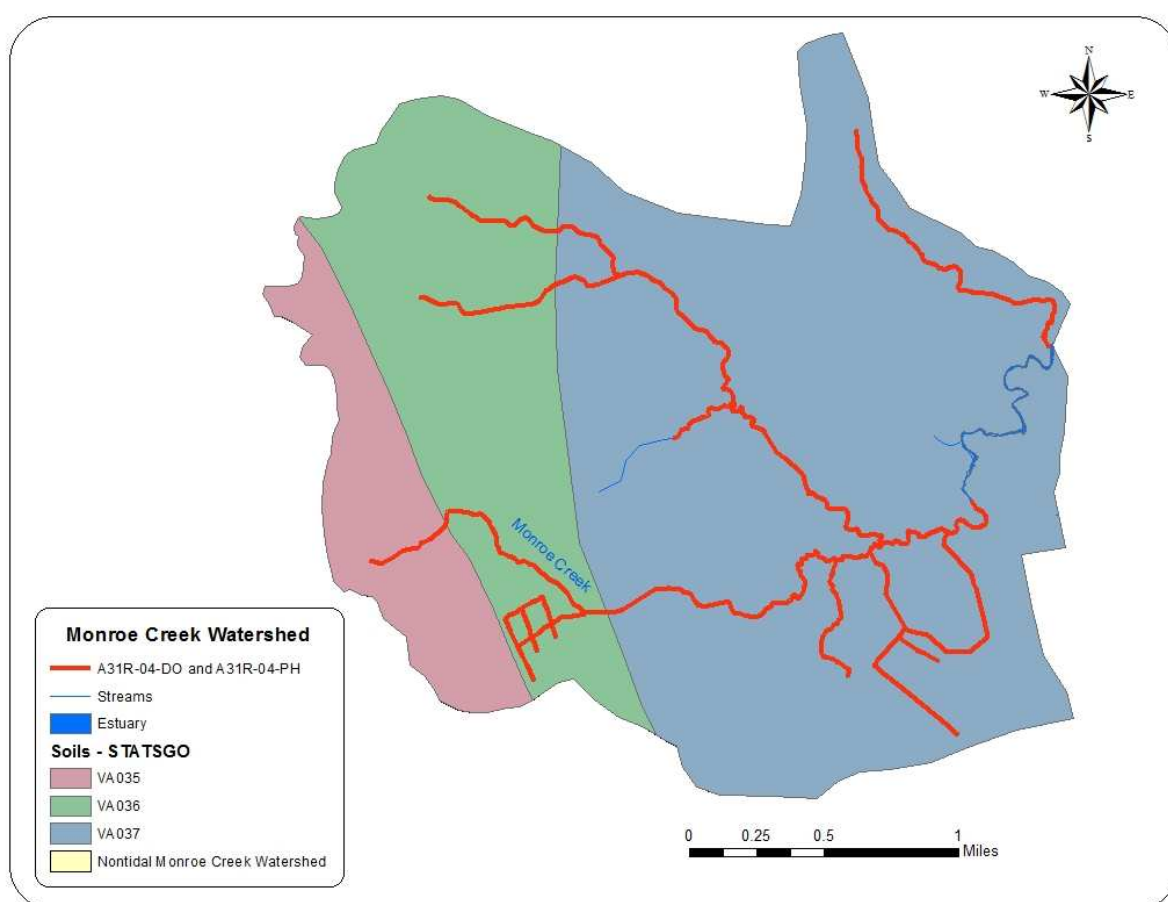
Soils for the Monroe Creek and tributaries watershed were documented utilizing the VA State Soil Geographic Database (STATSGO). Three general soil types were identified using in this database. Descriptions of these soil series were derived from queries to the USDA Natural Resources Conservation Service (NRCS) Official Soil Series Description web site (<http://soils.usda.gov/technical/classification/osd/index.html>). Figure 2 shows the location of these general soil types in the watershed.

Figure 2. Soil Characteristics of the Monroe Creek and tributaries Watershed.

The soils of the Craven-Mattaponi-Lenoir-Coxville (VA035) series are very deep in which the drainage ranges from somewhat poor to well drained and the permeability is typically slow to moderately slow. The soils

formed in flats or depressions from the lower to upper Coastal Plain and Piedmont Physiographic Provinces of the Atlantic Coast, in which the parent materials consists of fluvial and marine sediments.

Soils of the Tetotum-Nansemond-State-Emporia-Dragston-Nimmo-Bladen Series (VA036) are very deep and range from well drained to poorly drained. Permeability ranges from moderately rapid and/or rapid to moderately slow or slow. This soil series was formed in sandy or loamy fluvial and marine sediments on Coastal Plain uplands and stream terraces.

The Portsmouth - Roanoke -Rains - Eunola - Levy - Kalmia Series (VA037) are very deep, very poorly to moderately well drained soils. These soils are located on low stream or marine terraces and in marshes of the Atlantic Coastal Plain. These series are formed from fluvial and marine sediments. Permeability of these soil types ranges from very slow to rapid, depending on soil composition.

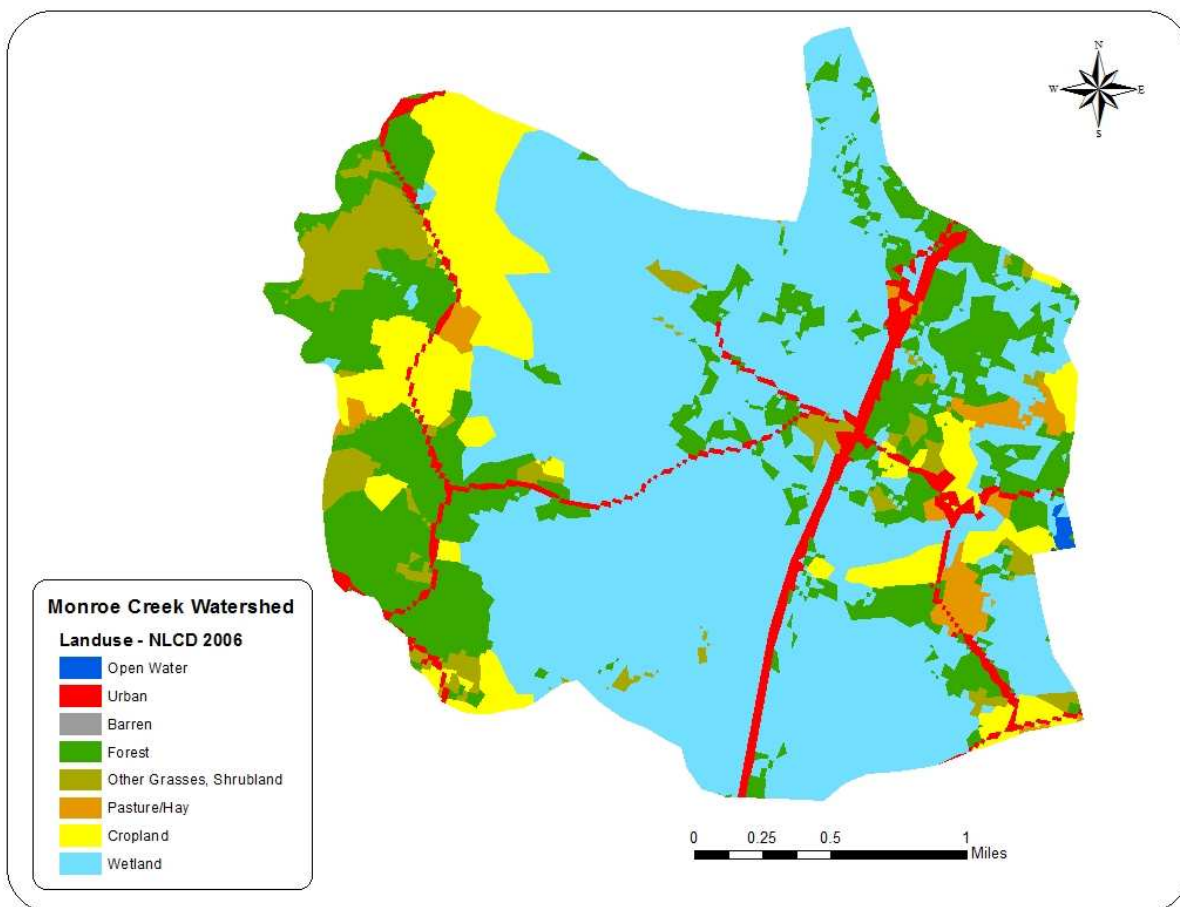
A map of the distribution of land use in the watershed (Figure 3) shows that urban land use is concentrated along US. Rt. 205 and county roads. Wetlands are concentrated very widely in a wide swath north to south through the watershed.

Figure 3. Land Use in the Monroe Creek and tributaries Watershed

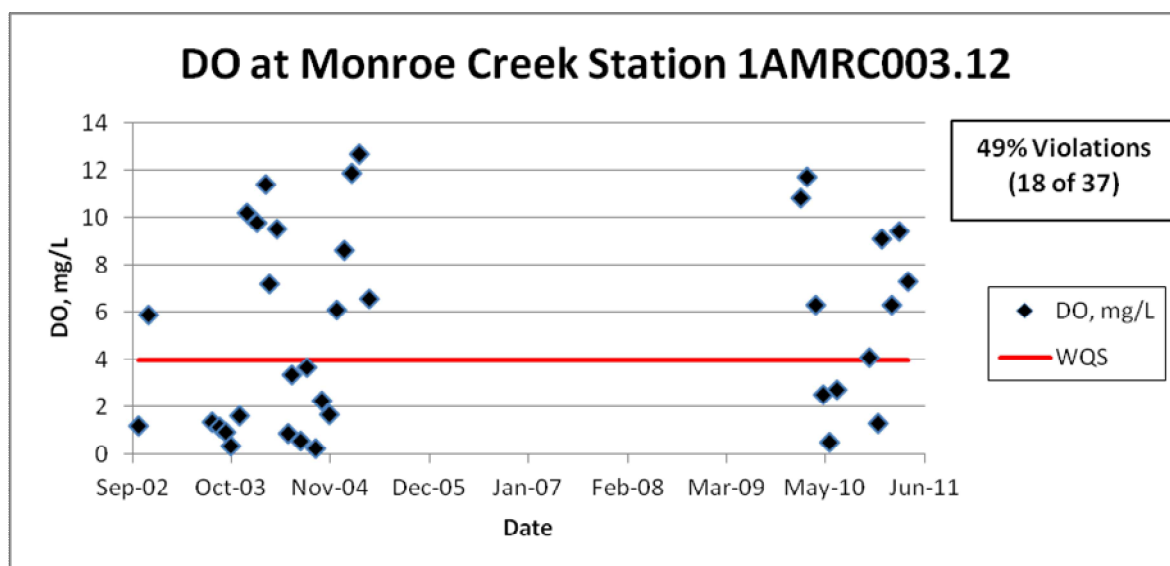
Figure 4. Time series of DO at Monroe Creek station 1AMRC003.12, omitting 4/23/1996 DO = 2.31 mg/l.

Time series graphs of all DO and pH data collected at the original listing station, Monroe Creek at station 1AMRC003.12, shows the DO ranged from 0.22 to 12.64 mg/L and the pH ranging from 3.6 to 6.25 S.U. (Figure 4 and Figure 5) respectively. The horizontal red line at the DO = 4.0 mark represents the minimum water quality standard in Figure 4. The data points below the DO = 4.0 line are violations of the water quality standard in Figure 4. The horizontal red line at the pH = 6.0 mark represents the minimum water quality standard in Figure 5. The data points below the pH = 6.0 line are violations of the water quality standard in Figure 5.

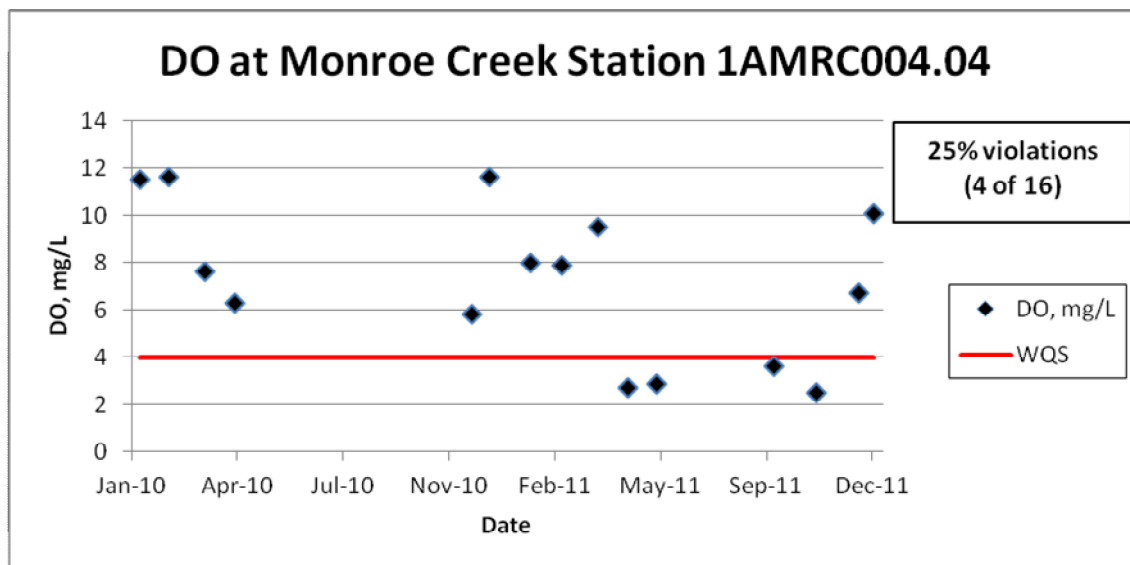
Figure 8. Time series of DO at Monroe Creek station 1AMRC004.04, omitting 4/23/1996 DO = 4.53 mg/l.

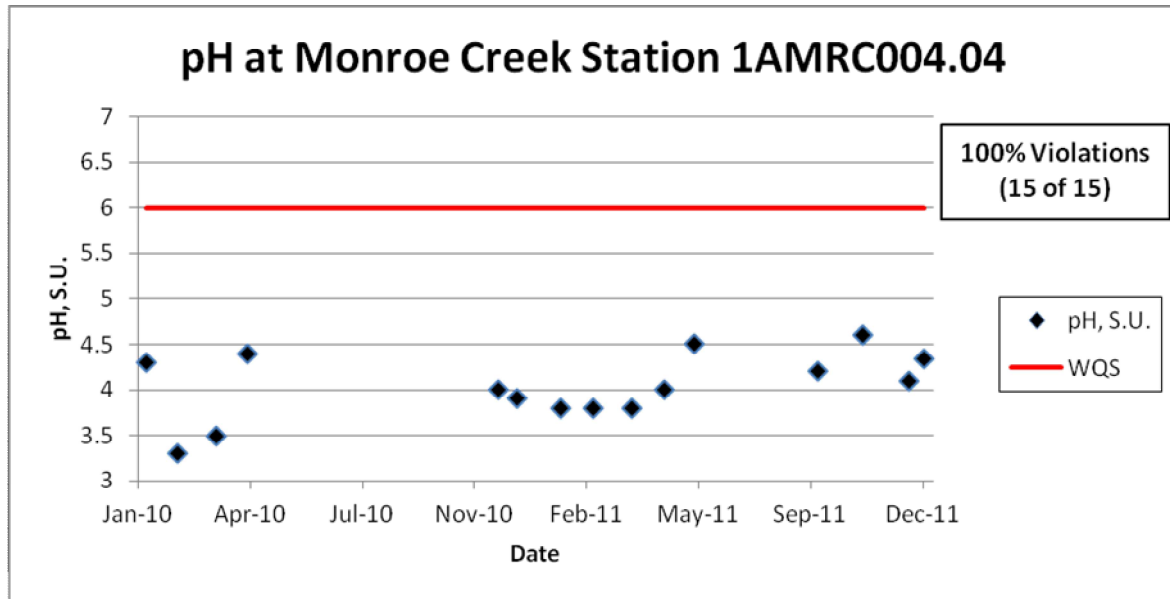
Figure 9. Time series of pH at Monroe Creek station 1AMRC004.04, omitting 4/23/1996 pH = 4.00 S.U.

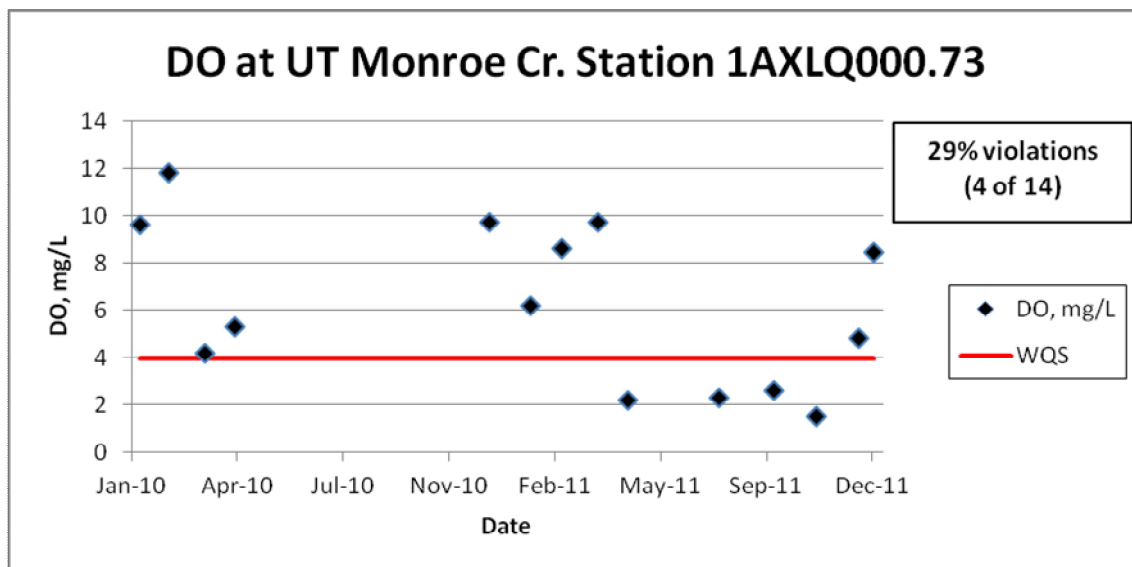
Figure 10. Time series of DO at UT Monroe Creek station 1AXLQ000.73.

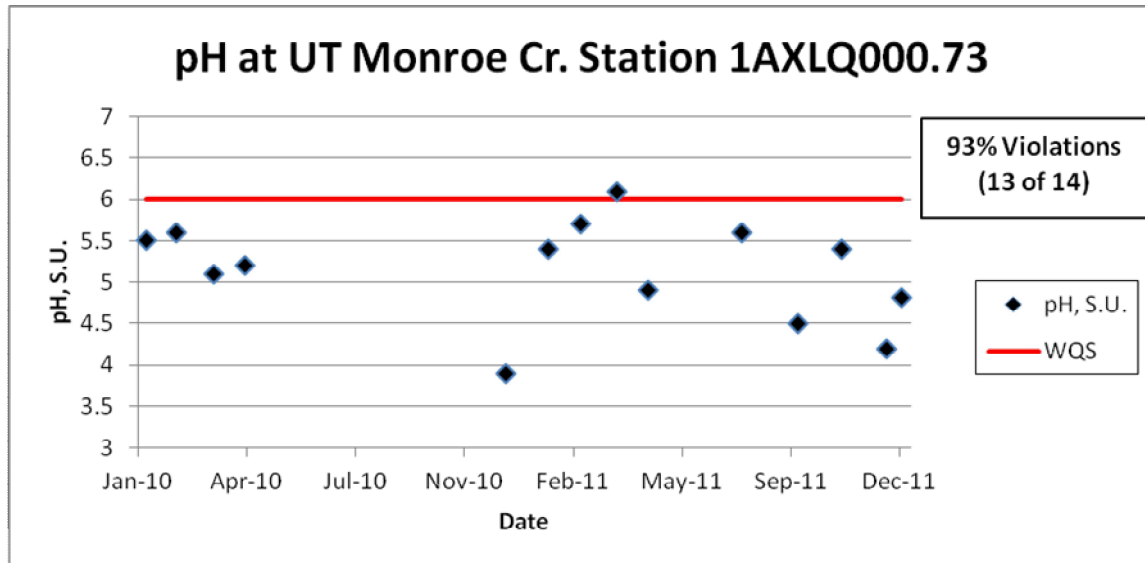
Figure 11. Time series of pH at UT Monroe Creek station 1AXLQ000.73.

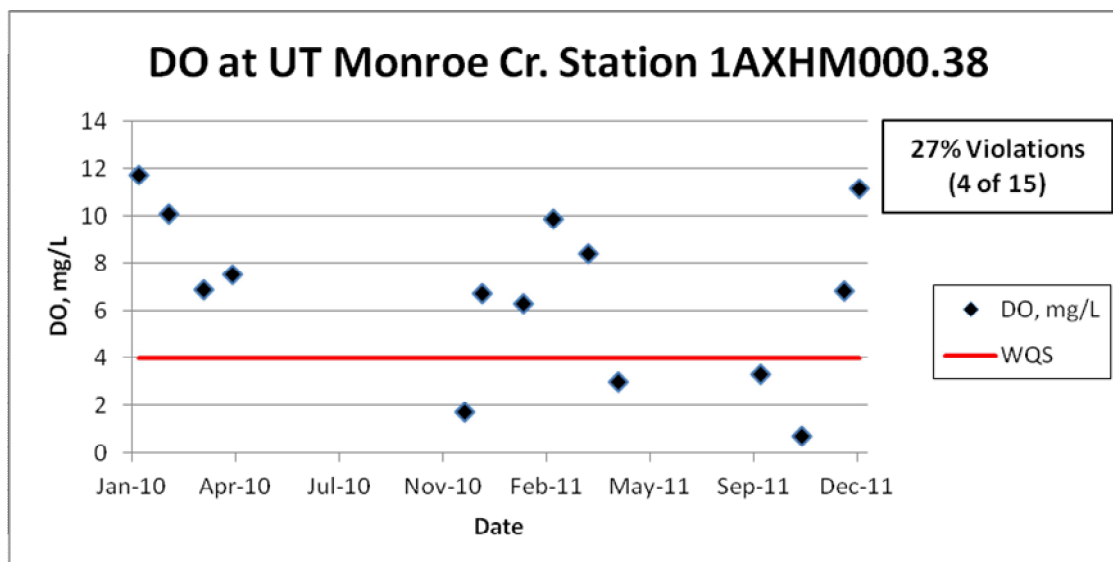
Figure 12. Time series of DO at UT Monroe Creek station 1AXHM000.38.

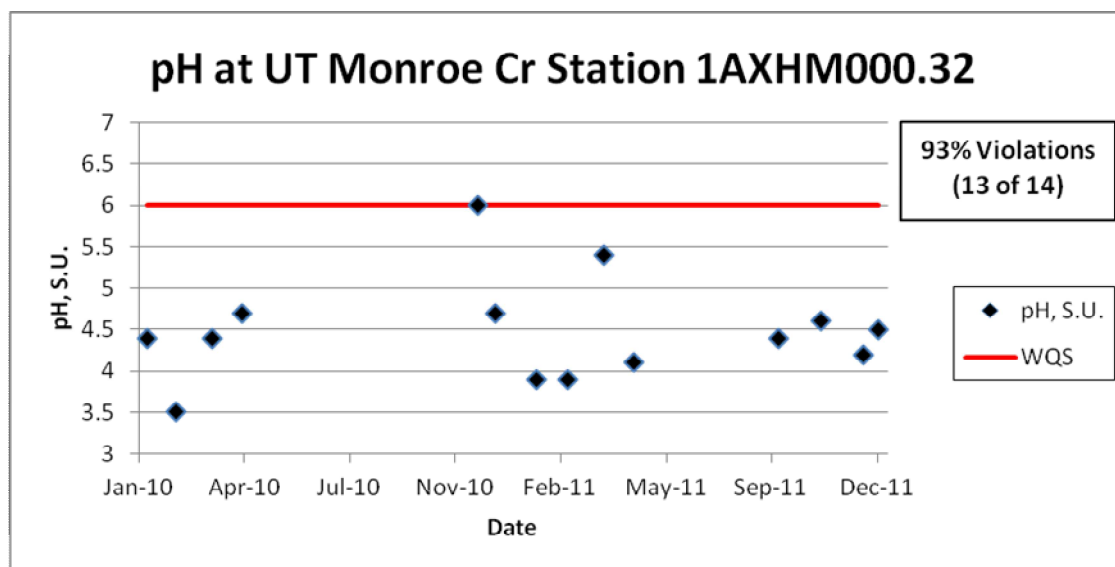
Figure 13. Time series of pH at UT Monroe Creek station 1AXHM000.38.

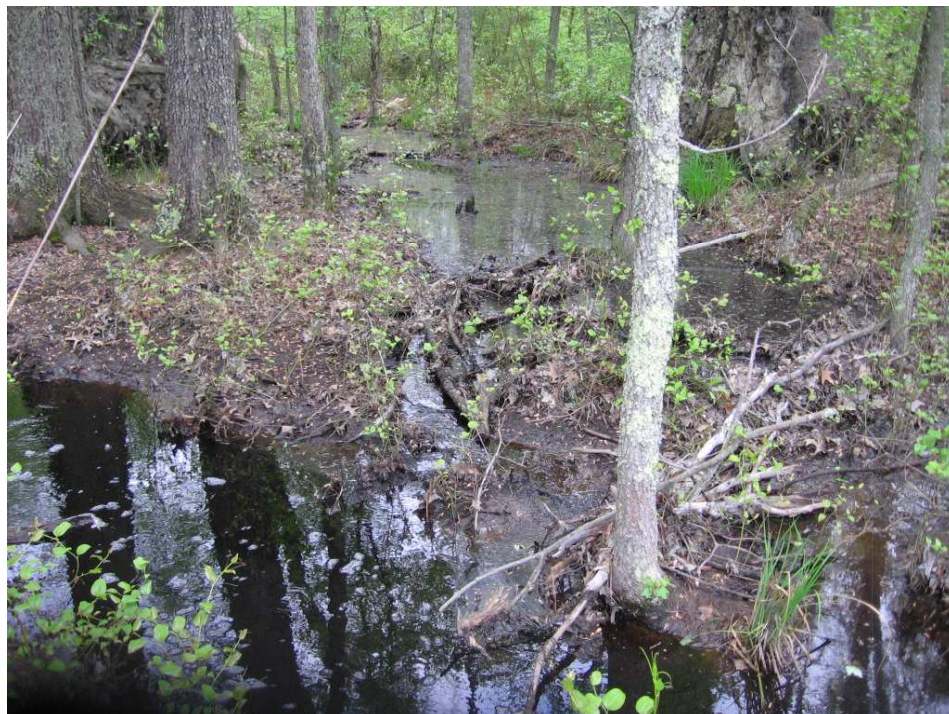
Figure 14. Monroe Creek, 1AMRC004.04 Rt. 205, Upstream.

Visual inspection of Monroe Creek and tributaries revealed swampy areas and heavy tree canopy in large swamp segments. Decomposition of vegetative matter from large swampy areas lowers DO and pH as decay occurs. Note the very blackish tannic water color (Figures 14 and 15).

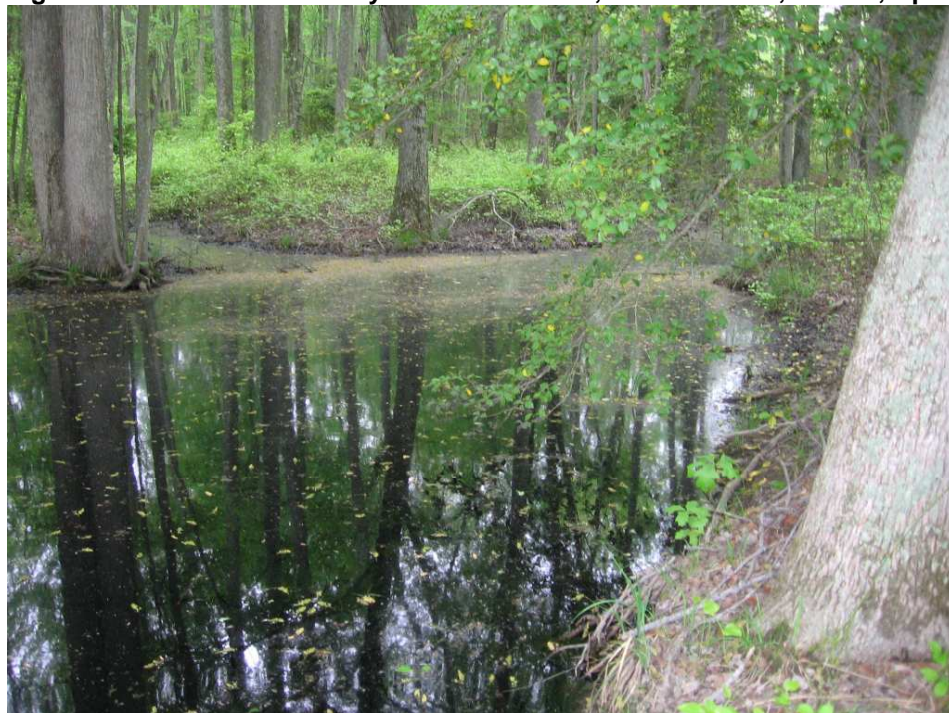
Figure 15. Unnamed Tributary of Monroe Creek, 1AXHM000.38, Rt. 205, Upstream.

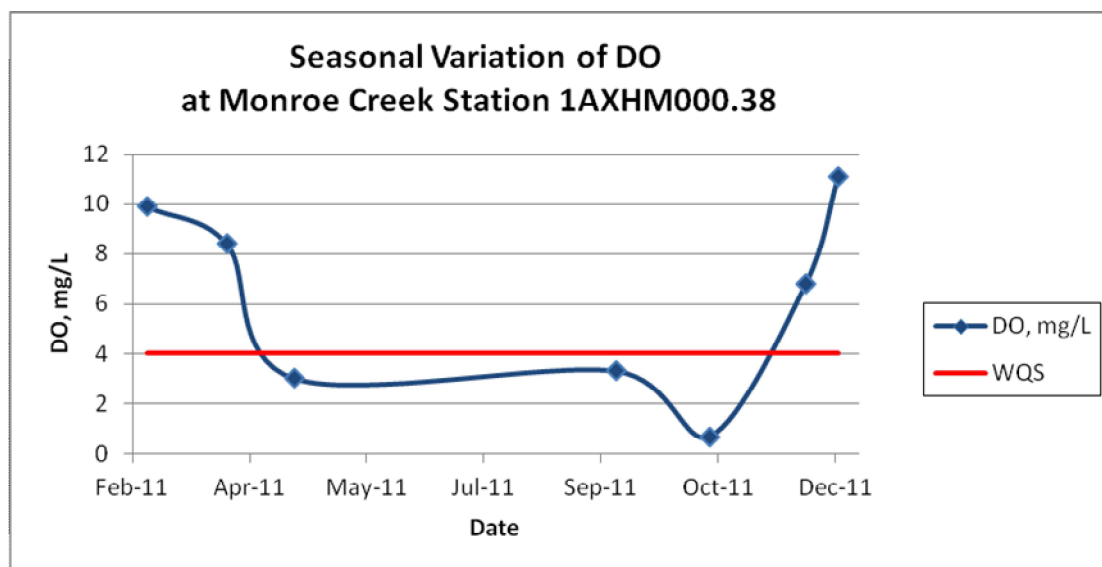
The 2011 DO data collected at the UT to Monroe Creek station 1AXHM000.38 were graphed to demonstrate the natural seasonal DO fluctuation due to the inverse relationship between water temperature and DO. DO is high in the winter months while water temperatures are low, and low in the summer months when water temperatures are high. This is depicted in Figure 14.

Figure 14. Seasonal DO Variation at UT to Monroe Creek at Rt. 205, February to December 2011.

Monroe Creek exhibits natural seasonal DO fluctuation due to the inverse relationship between water temperature and DO.
